# ENGINEERING TEST REPORT

ETR - 924

TITLE: Test Results of the RAH-66 Main Rotor Ballistically Damaged Flexbeam  
DATE: 4 August 1997  
A/C SERIES: RAH-66  
A/C MODEL: RAH-66 Prototype  
SYSTEM: Main Rotor  
CHARGE NO: CB571-300  
CONTRACT NO: DAAJ02-97-M-0001

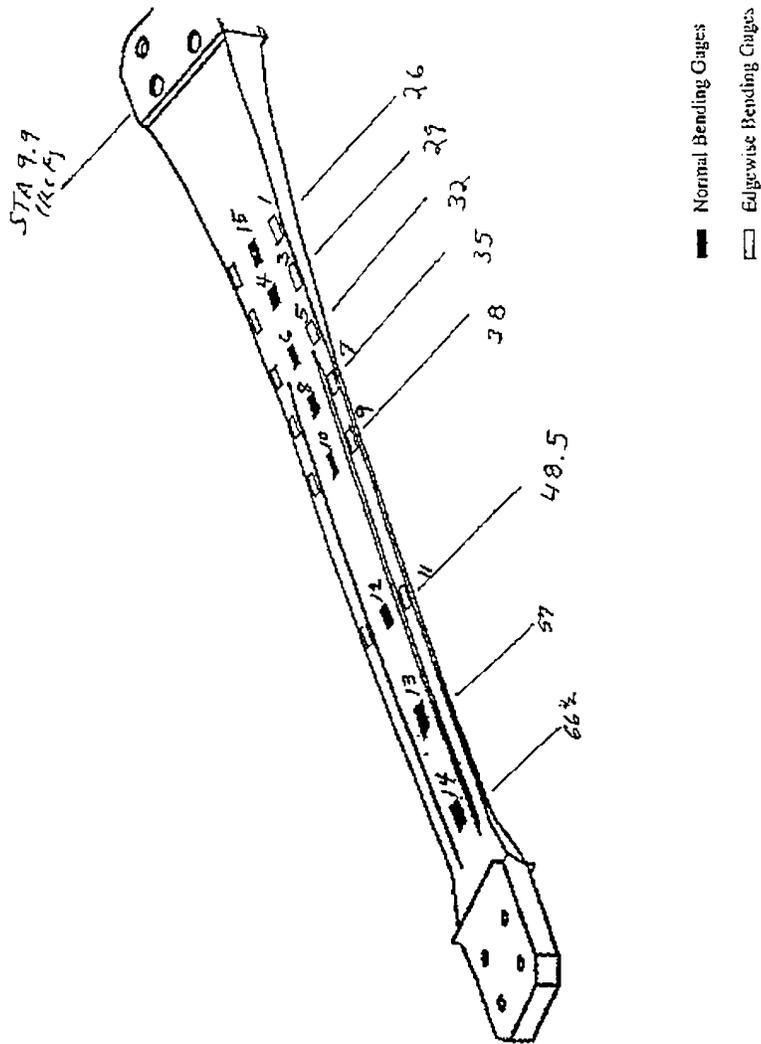
**Figure 4 Ballistically Damaged Flexbeam S/N 0044 Instrumentation**

The S/N 0044 flexbeam was instrumented at AATD with the bending bridges shown in Figure 4. Since the ballistic damage made the centerline flatwise bending bridges inoperative, secondary flatwise bending bridges were installed slightly offset chordwise.

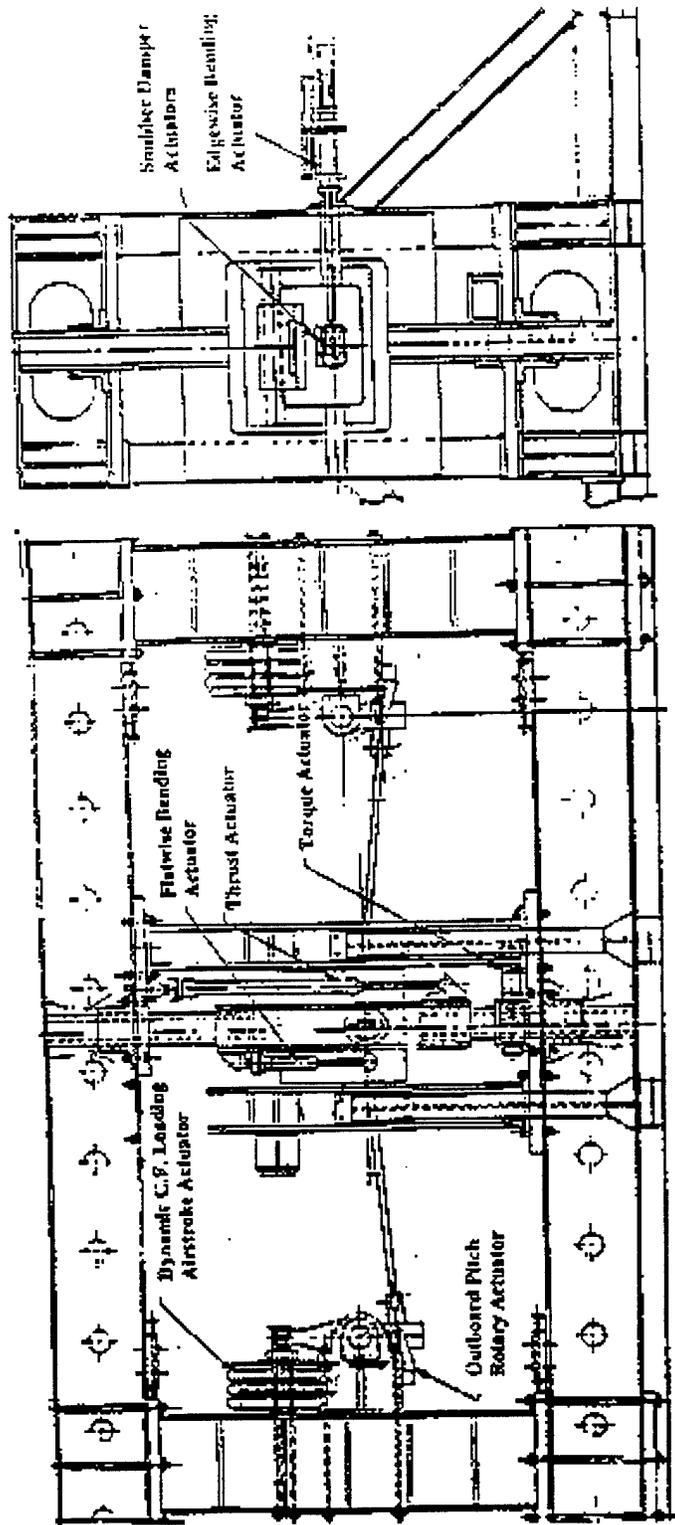
Figure 10 Sketch of Test Facility

The ballistically damaged RAH-66 Comanche flexbeam was fatigue tested in the Reference 2.2.1 test facility, Figure 9 & 10. This facility is designed to test two specimens simultaneously. The second specimen, S/N 0001, is not considered a test specimen and was mounted in the facility to allow testing of the ballistic flexbeam, S/N 0044. The flexbeam specimens were mounted in a facility hub 180 degrees apart as shown in Figure 9. The facility hub is representative of the aircraft hub in the flexbeam attachment area. A dummy quill shaft flange was included in the hub assembly to assure proper loading of the inboard flexbeam attachment bolts. The outboard ends of the flexbeams were attached to facility spindles which provided centrifugal force through the use of a pneumatic bellows arrangement, and torsional pitching moment through the use of an electrically controlled hydraulic rotary actuator. The facility provided flatwise shear by raising the center carriage vertically. Flatwise moment was produced by rocking the center carriage about the flapwise axis. The edgewise moment was produced by translating the center carriage horizontally. Both the flatwise and edgewise motions were imparted to the flexbeams through the use of electronically controlled hydraulic actuators. An electronic cycle counter monitored the number of test cycles applied to the specimens. Snubber/damper preload was simulated through a mechanical clamping assembly, and the vibratory damper chordwise shear loads were simulated through an electronically controlled hydraulic actuator.
